Case study

An investigation into failure analysis of interfering part of a steam turbine journal bearing

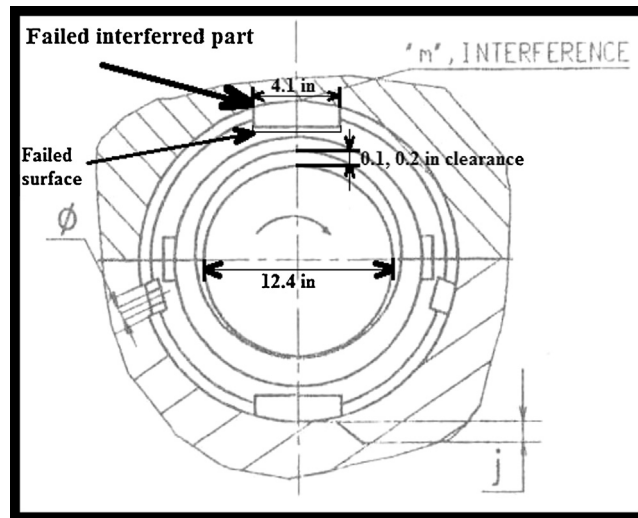
Fig. 1. Schematics represent the journal bearing assembly.

During repairing of a 320,000 kW steam turbine, after disassembling of bearing journal-pad type, some surface damages on its interfering part have been observed. Fig. 1 illustrates the general location view of this damaged part in journal bearing
